**Flood Control Project Maintenance  
Levee Inspections**

## Maintenance Issue Types Only, Levee Inspection Report By Mile - Spring 2018

### Sutter Maintenance Yard Maintenance Area 0005

Waterway	Bank	Unit Miles	Inspection Start/End	Inspector
Unit No. 01 Butte Creek	Left	15.08	03/14/2018 03/14/2018	Bob Duffey

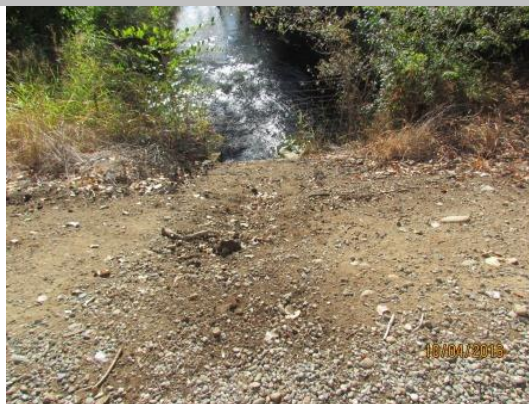
Photo 1 of 1 : SP\_2018\_MA0005\_196\_46\_20180305\_00023.jpg

LM Start	0.07	Rating **	M	Issue No.	46
LM End	0.07	Issue Type +	Ma	Location *	LS
Category	Earthen Levee			GPS Latitude/Longitude	
				Start	End
Item	Slope Stability			39.696611 °	39.696611 °
				-121.774349 °	-121.774349 °
DWR ID	DWR_MA0005_01_f_2016_46				
Comment Code					
S2 : Repair the levee slope damaged by foot traffic and prevent access where possible.					
Inspector Comment

View of the damaged slope by foot traffic.

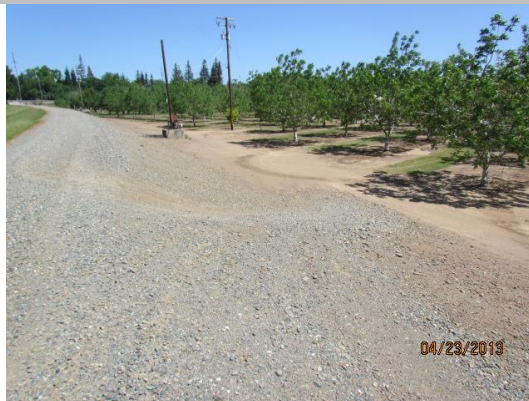
Photo 1 of 1 : SP\_2018\_MA0005\_196\_16\_20180305\_00006.jpg

LM Start	1.61	Rating **	M	Issue No.	16
LM End	1.61	Issue Type +	Ma	Location *	LS
Category	Earthen Levee			GPS Latitude/Longitude	
				Start	End
Item	Slope Stability			39.676129 °	39.676129 °
				-121.778171 °	-121.778171 °
DWR ID	DWR_MA0005_01_s_2013_16				
Comment Code					
S3 : Repair the levee slope damaged by vehicle traffic and prevent access where possible.					
Inspector Comment

View of the unauthorized vehicle ramp on the landside slope.

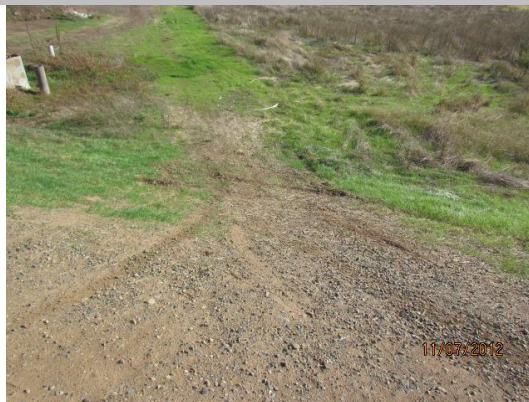
Photo 1 of 1 : SP\_2018\_MA0005\_196\_9\_20180305\_00004.jpg

LM Start	2.54	Rating **	M	Issue No.	9
LM End	2.54	Issue Type +	Ma	Location *	LS
Category	Earthen Levee			GPS Latitude/Longitude	
				Start	End
Item	Slope Stability			39.663876 °	39.663876 °
				-121.784014 °	-121.784014 °
DWR ID	DWR_MA0005_01_f_2012_9				
Comment Code					
S3 : Repair the levee slope damaged by vehicle traffic and prevent access where possible.					
Inspector Comment

View of the vehicle erosion along the landside slope.

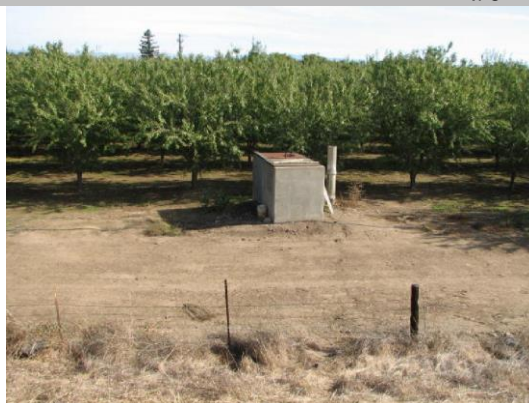
Photo 2 of 3 : UCIP\_SP\_2018\_51949\_67930.jpg

FS\_ID:51949  
DS\_ID:1616  
EP\_NO: N/A  
Repair Type: No Action Needed  
Crossing Status: Found  
UCIP Comments: 5/15/2017 Crossing appears to be in good condition. LS inlet is located in the Distribution box on the LS toe. This is an overflow pipe used to regulate water levels in side the box. Pipe has been selected to be internally cleaned and inspected as part fo the DMP project. (DWR Sutter Yard- AFreitag)11/15/2016 Crossing appears to be in good condition. (DWR Sutter Yard- AFreitag)5/9/2016 Crossing appears to be in good condition.8/5/2015 WS pipe end is being overgrown by trees and other vegetation. Needs to be cleared back.12/8/2014 Same as last inspection.6/11/2014 Same as last inspection.11/20/2013 Same as last inspection.5/29/2013 Same as last inspection.  
FIELD\_STRUCT\_DESC: 24-inch corrugated metal drainage pipe through the levee, 16.5 feet below the crown. Slide gate in a corrugated metal riser on the waterside (WS) slope. Flap gate on the WS toe. Inlet on the landside (LS) toe, not found. [Additional Reference(s): DWR Levee Log, 1990. USACE Sacramento O&M Manual 516, April 1960, (Station 381+36)].

Unable to locate inlet on LS.

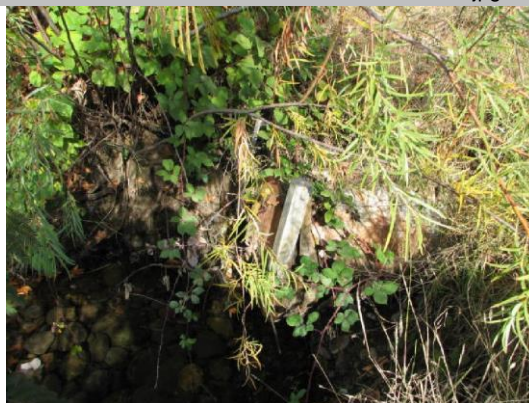
Photo 3 of 3 : UCIP\_SP\_2018\_51949\_67929.jpg

Flap gate in channel at WS toe.

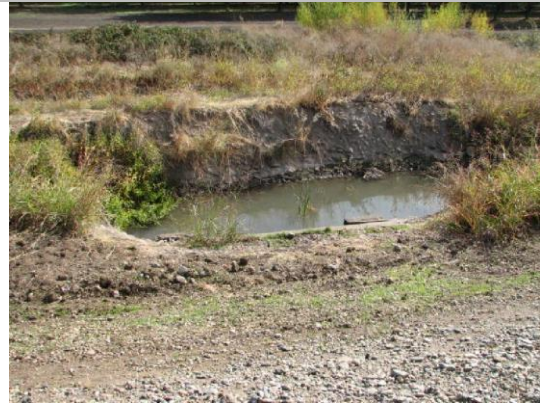
Photo 1 of 3 : UCIP\_SP\_2018\_51954\_67939.jpg

FS\_ID:51954  
DS\_ID:1768  
EP\_NO: N/A  
Repair Type: Non-Urgent  
Crossing Status: Found  
UCIP Comments: 5/15/2017 Abandoned and needs to be done properly. A sink hole formed in the WS toe road and revealed the location of the WS pipe end. Sink hole will need to be repaired before the next high water season but the pipe has been selected to be internally cleaned and camera inspected as part of the DMP project so it will have needed to be excavated along the WS end anyways. (DWR Sutter Yard- A Freitag) 11/15/2016 Abandoned. Needs standpipe cover. (DWR Sutter Yard- A Freitag) 5/9/2016 Abandoned pipe. Needs a cover for standpipe. 8/5/2015 Abandoned pipes. Need covers made for tops of standpipes to prevent falls. 12/8/2014 Same as last inspection. 6/11/2014 Same as last inspection. 11/19/2013 Same as last inspection. 5/29/2013 Same as last inspection. Land owner said pipes are abandoned and no longer used. Covers should be made for top of standpipe to prevent falls. Pipes should be properly abandoned. 10/30/2012 Pipe 1/2 filled with soil at slide gate on WS. FIELD\_STRUCT\_DESC: "ABANDONED" 2 of 2: 36-inch corrugated metal drainage pipe through the levee, 11 feet below the crown. Slide gate in a 54-inch corrugated metal riser on the waterside (WS) slope. Concrete "U" shaped headwall on the landside (LS). [Additional Reference(s): DWR Levee Log, 1990. Sacramento O&M Manual 516, April 1960, (Station 470+00)].

Headwall at LS toe.

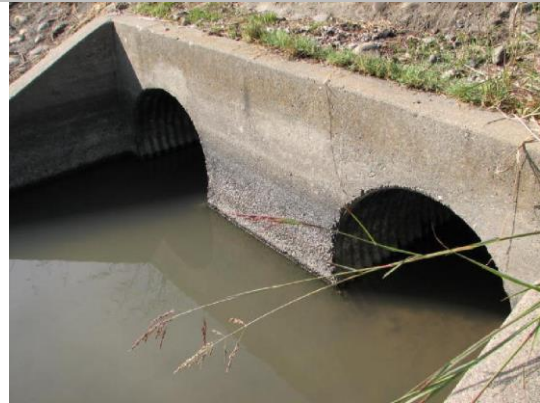
Photo 2 of 3 : UCIP\_SP\_2018\_51954\_67938.jpg

Headwall at LS toe.

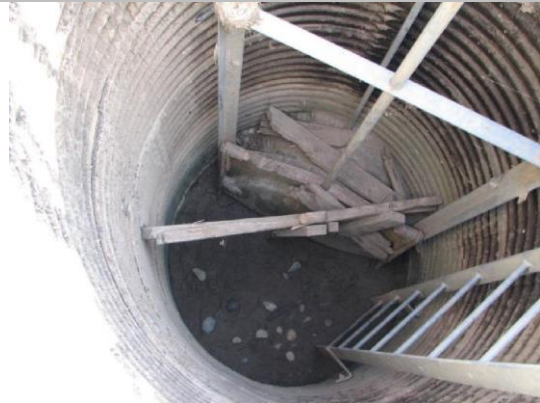
Photo 3 of 3 : UCIP\_SP\_2018\_51954\_67937.jpg

Slide gate at bottom of cmp riser.

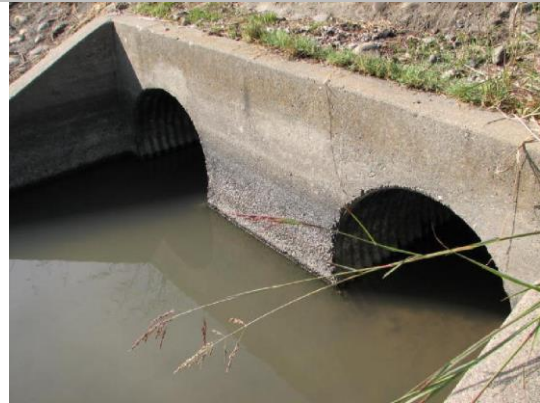
Photo 1 of 2 : UCIP\_SP\_2018\_51955\_67941.jpg

FS\_ID:51955  
DS\_ID:1620  
EP\_NO: N/A  
Repair Type: Non-Urgent  
Crossing Status: Found  
UCIP Comments: 5/15/2017 Abandoned and needs to be done properly. A sink hole formed in the WS toe road and revealed the location of the WS pipe end. Sink hole will need to be repaired before the next high water season but the pipe has been selected to be internally cleaned and camera inspected as part of the DMP project so it will have needed to be excavated along the WS end anyways. (DWR Sutter Yard- A Freitag) 11/15/2016 Abandoned. Needs cover for the standpipe. (DWR Sutter Yard- A Freitag) 5/9/2016 Abandoned pipe. Needs a cover for the standpipe. 8/5/2015 Abandoned crossing. Covers need to be made for tops of standpipes to prevent falls. 12/8/2014 Same as last inspection. 6/11/2014 Same as last inspection. 11/19/2013 Same as last inspection. 5/29/2013 Same as last inspection. Land owner said pipes are abandoned and no longer used. Covers should be made for top of standpipe to prevent falls. Pipes should be properly abandoned. 10/30/2012 Pipe 1/2 filled with soil at slide gate end.

Headwall at LS toe.

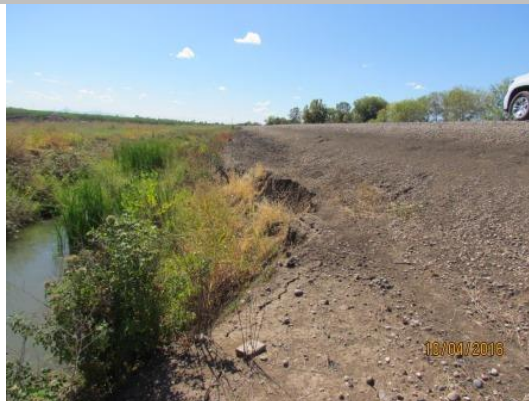
Photo 1 of 2 : SP\_2018\_MA0005\_196\_56\_20180305\_00029.jpg

LM Start	5.81	Rating **	U	Issue No.	56
LM End	5.81	Issue Type +	Ma	Location *	LS
Category	Earthen Levee			GPS Latitude/Longitude	
				Start	End
Item	Erosion / Bank Caving			39.621261 °	39.621261 °
				-121.773973 °	-121.773973 °
DWR ID	DWR_MA0005_01_f_2016_56				
Comment Code					
E2 : Schedule repair of erosion site prior to the next inspection.					
Inspector Comment

View of the landside toe erosion.

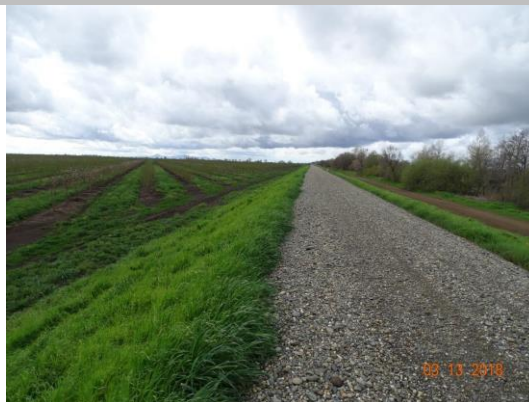
Photo 1 of 1 : SP\_2018\_MA0005\_196\_65\_20180402\_00089.jpg

View of the native grasses on both slopes.

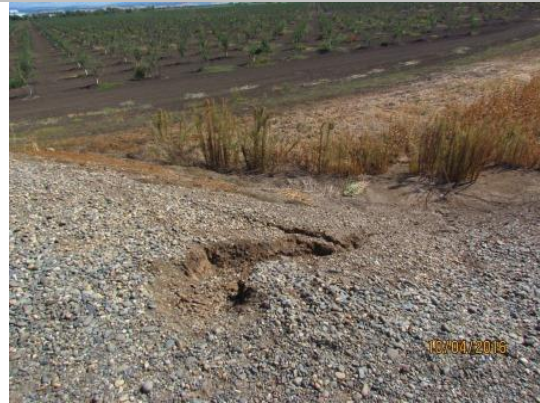
Photo 1 of 1 : SP\_2018\_MA0005\_196\_57\_20180305\_00031.jpg

LM Start	7.08	Rating **	M	Issue No.	57
LM End	7.08	Issue Type +	Ma	Location *	LS
Category	Earthen Levee			GPS Latitude/Longitude	
				Start	End
Item	Erosion / Bank Caving			39.604357 °	39.604357 °
				-121.783665 °	-121.783665 °
DWR ID	DWR_MA0005_01_f _ 2016_57				
Comment Code					
E2 : Schedule repair of erosion site prior to the next inspection.					
Inspector Comment

View of the landside slope erosion.

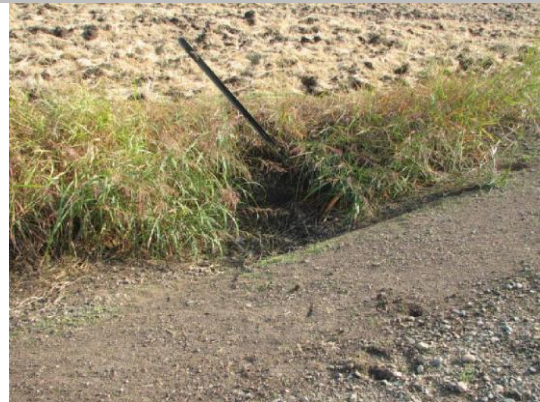
Photo 1 of 2 : UCIP\_SP\_2018\_51970\_67970.jpg

Comment Code						
Inspector Comment						
FS_ID:51970						
DS_ID:1628						
EP_NO: N/A						
Repair Type: Non-Urgent						
Crossing Status: Found						
UCIP Comments: 5/16/2017 LS inlet is almostc ompletely buried.						
Nothing visible on the WS. Pipe has been selected to be internally						
cleaned and inspected as part of the DMP poject. (DWR Sutter Yard-						
AFreitag)11/15/2016 Appears abandoned and should be done so						
properly. (DWR Sutter Yard- AFreitag)5/11/2016 Possibly an						
abandoned crossing. LS inlet was over 50% buried and nothing was						
found on the WS.8/4/2015 LS pipe end filled about 50% with soil and						
WS pipe end is buried.12/8/2014 Same as last						
inspection.6/11/2014 Same as last inspection.11/19/2013 Same as						
last inspection.5/29/2013 Same as last inspection.10/30/2012 Pipe						
filled with soil and outlet/appurtances are burried.						
FIELD_STRUCT_DESC: *ABANDONED* 24-inch corrugated metal

Headwall at LS toe.

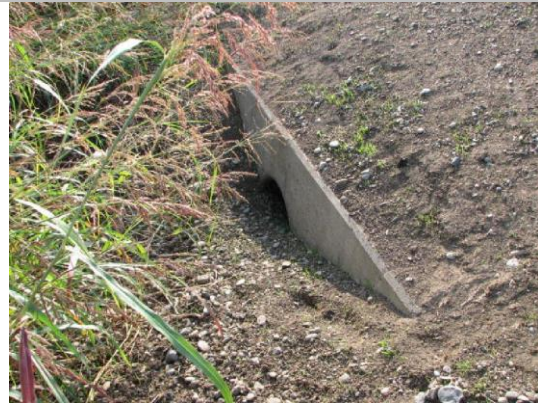
Photo 2 of 2 : UCIP\_SP\_2018\_51970\_67969.jpg

Headwall at LS toe.

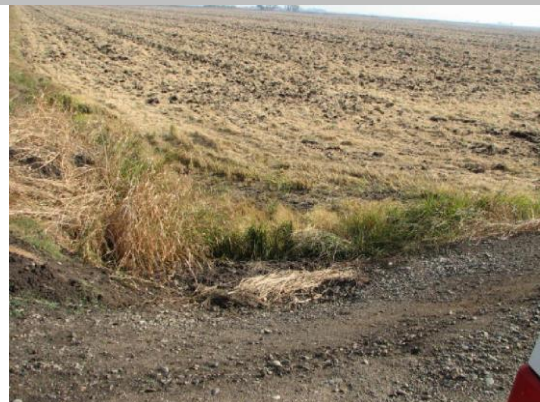
Photo 2 of 3 : UCIP\_SP\_2018\_51972\_67972.jpg

FS\_ID:51972  
DS\_ID:1629  
EP\_NO: N/A  
Repair Type: Non-Urgent  
Crossing Status: Found  
UCIP Comments: 5/16/2017 LS inlet is half blocked off by flash boards and sediment. WS flap gate is blocked closed by sediment. Pipe has been selected to be internally cleaned and inspected as part of the DMP project. (DWR Sutter Yard- AFreitag)11/15/2016 LS inlet was unburied and entire pipe is about 25% full of soil. WS flapgate was shut and partially buried. (DWR Sutter Yard- AFreitag)5/11/2016 WS flap gate was about 50% buried and LS was 100% buried. Appears to be an abandoned crossing.8/4/2015 WS flap gate is partially buried by soil and being overgrown with vegetation. LS pipe end was underwater and suspected to still be completely buried with soil.12/8/2014 Same as last inspection.6/11/2014 Same as last inspection.11/19/2013 Same as last inspection.5/29/2013 Same as last inspection.10/30/2012 Pipe filled with soil.

Buried inlet at LS toe.

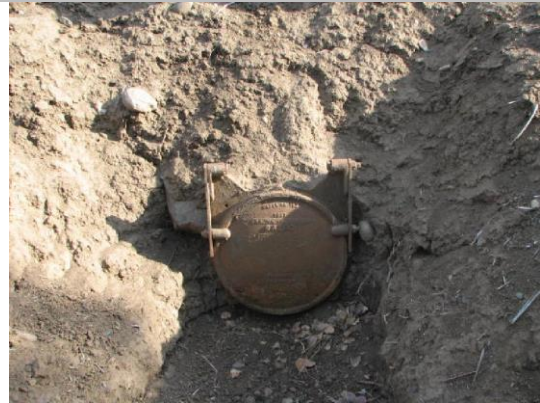
Photo 3 of 3 : UCIP\_SP\_2018\_51972\_67971.jpg

Comment Code						
Inspector Comment						
FS_ID:51972 DS_ID:1629 EP_NO: N/A Repair Type: Non-Urgent Crossing Status: Found UCIP Comments: 5/16/2017 LS inlet is half blocked off by flash boards and sediment. WS flap gate is blocked closed by sediment. Pipe has been selected to be internally cleaned and inspected as part of the DMP project. (DWR Sutter Yard- A Freitag)11/15/2016 LS inlet was unburied and entire pipe is about 25% full of soil. WS flapgate was shut and partially buried. (DWR Sutter Yard- A Freitag)5/11/2016 WS flap gate was about 50% buried and LS was 100% buried. Appears to be an abandoned crossing.8/4/2015 WS flap gate is partially buried by soil and being overgrown with vegetation. LS pipe end was underwater and suspected to still be completely buried with soil.12/8/2014 Same as last inspection.6/11/2014 Same as last inspection.11/19/2013 Same as last inspection.5/29/2013 Same as last inspection.10/30/2012 Pipe filled with soil. FIELD_STRUCT_DESC: 24-inch corrugated metal drainage pipe through the levee, 9.3 feet below the crown. Flap gate on the waterside (WS). Concrete headwalls at the landside (LS) and the WS toes. [Additional Reference(s): DWR Levee Log, 1990. USACE Sacramento O&M Manual 515, April 1955, (Station 609+79). USACE As-Built Drawing No. 50-4-2637, Exhibit B, Sheet 3, April 1950, (Station 609+78.5)]. FS Date: 5/31/2017 1:59:10 PM

Flap gate at WS toe.

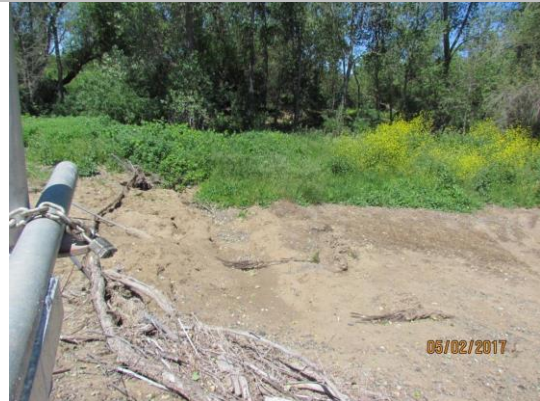
Photo 1 of 1 : SP\_2018\_MA0005\_196\_67\_20180305\_00032.jpg

View of erosion along the waterside slope.

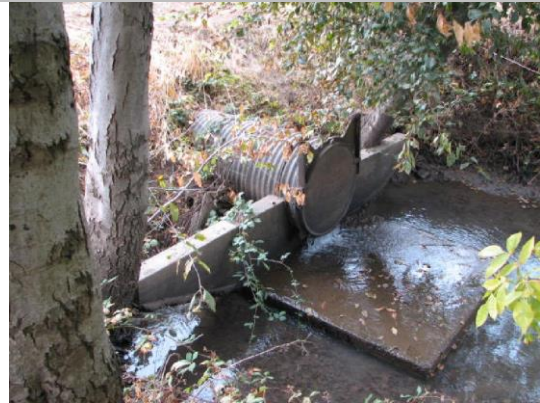
Photo 3 of 3 : UCIP\_SP\_2018\_51999\_68031.jpg

Wingwalls of headwall not supported by soil.

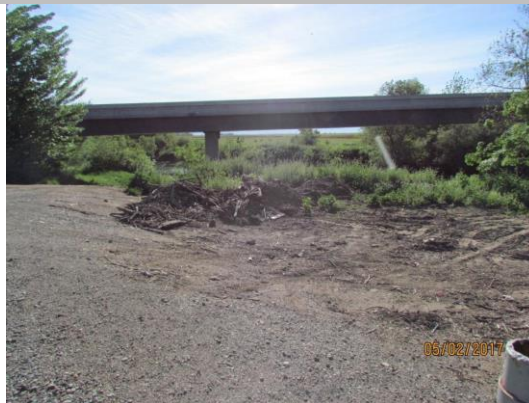
Photo 1 of 1 : SP\_2018\_MA0005\_197\_69\_20180305\_00034.jpg

View of the debris along the waterside toe.

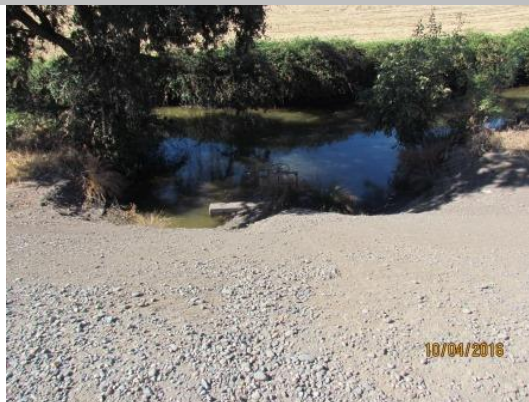
Photo 1 of 1 : SP\_2018\_MA0005\_197\_49\_20180305\_00024.jpg

View of the landside toe erosion.

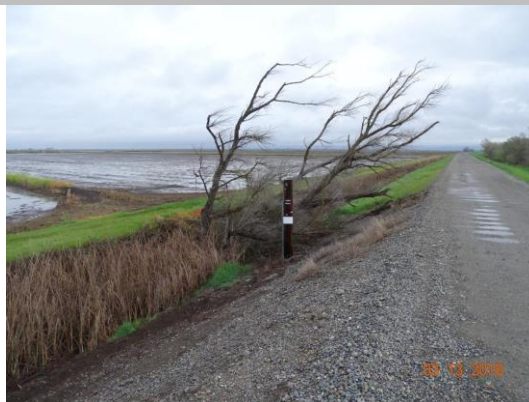
Photo 1 of 1 : SP\_2018\_MA0005\_197\_64\_20180402\_00099.jpg

View of the tree on the landside slope and toe.

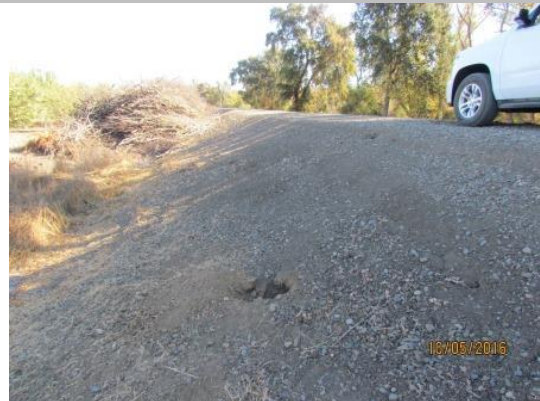
Photo 1 of 2 : SP\_2018\_MA0005\_197\_53\_20180305\_00025.jpg

View of the rodent holes along the landside slope.

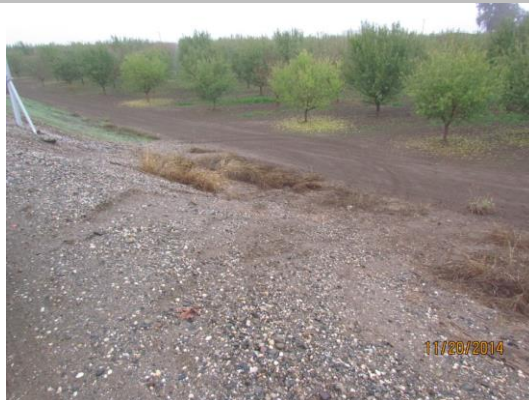
Photo 1 of 2 : SP\_2018\_MA0005\_197\_13\_20180305\_00005.jpg

View of the vehicle erosion along the landside slope.

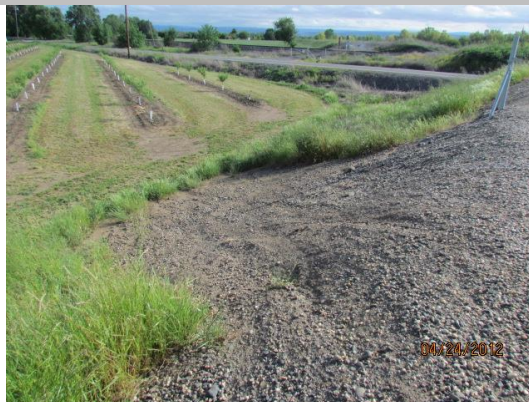
Photo 2 of 2 : SP\_2018\_MA0005\_197\_13\_20180305\_00006.jpg

View of the vehicle erosion along the slope.

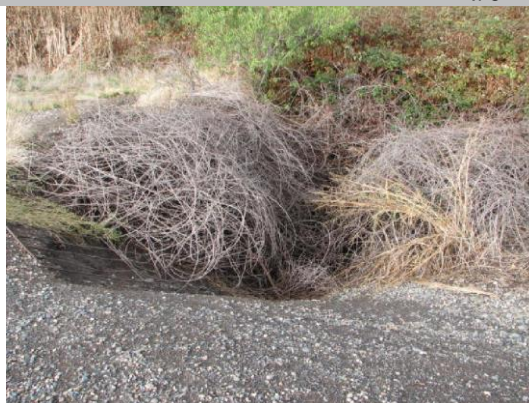
Photo 2 of 3 : UCIP\_SP\_2018\_52062\_68404.jpg

Brambles and soil over pipe at inlet.

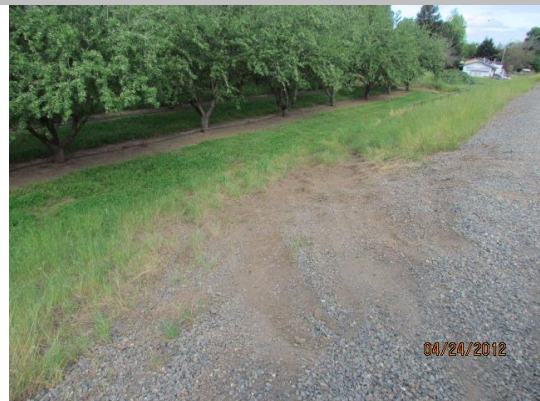
Photo 1 of 1 : SP\_2018\_MA0005\_197\_18\_20180305\_00007.jpg

View of the vehicle erosion along the slope of the levee.

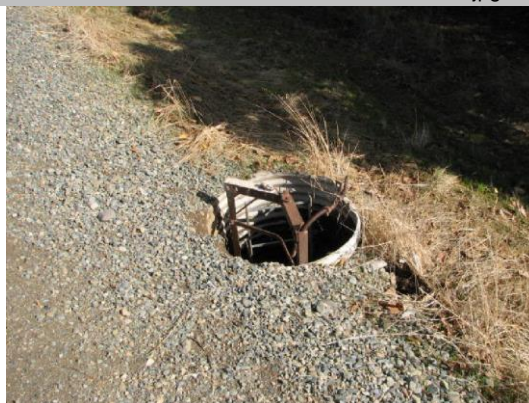
Photo 1 of 3 : UCIP\_SP\_2018\_52072\_68465.jpg

Broken slide gate in CM riser on WS slope.

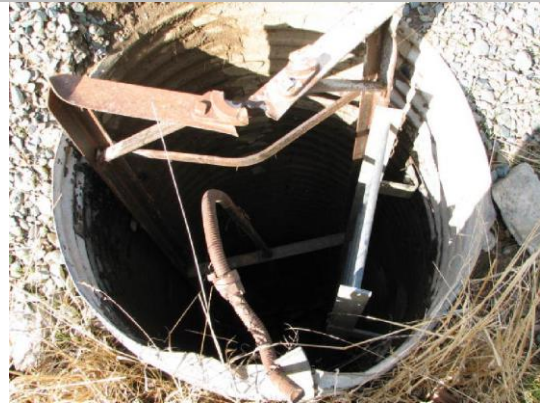
Photo 3 of 3 : UCIP\_SP\_2018\_52072\_68463.jpg

Broken slide gate in CM riser on WS slope.

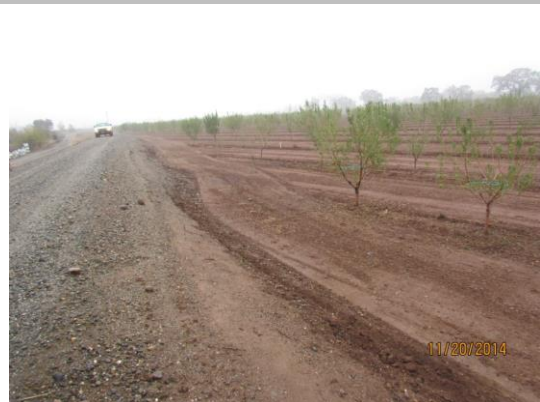
Photo 1 of 1 : SP\_2018\_MA0005\_197\_43\_20180305\_00019.jpg

View of the tilling into the landside slope.
